# Manhole Inspection Summary

Manhole # S33QQ1015MH

Insp Date: **6/26/08 9:36 AM**

**Location** Address: **200 WINSTON AVE**

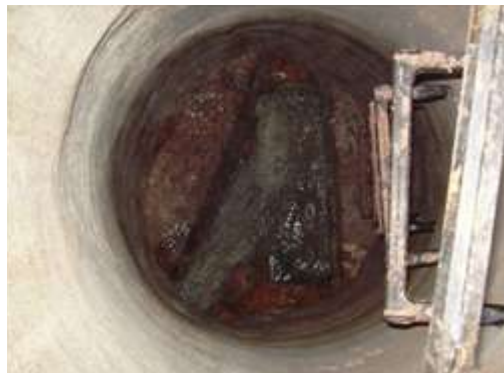
Top View

Adjustment and Barrel infiltration.  
Evidence of surcharge - Bench debris.

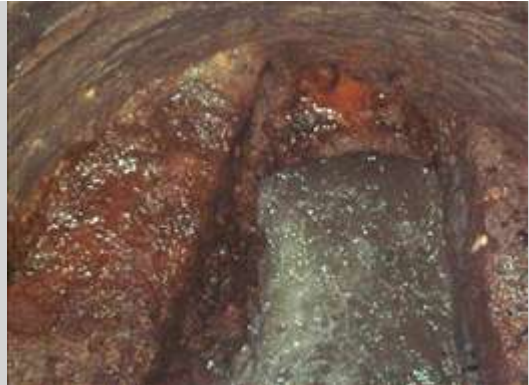
### 18 in. Circular Gravity Sewer Pipe Out @ 12 O'Clock

Infiltration: **Evidence** Pipe Seal Cond: **Unknown**

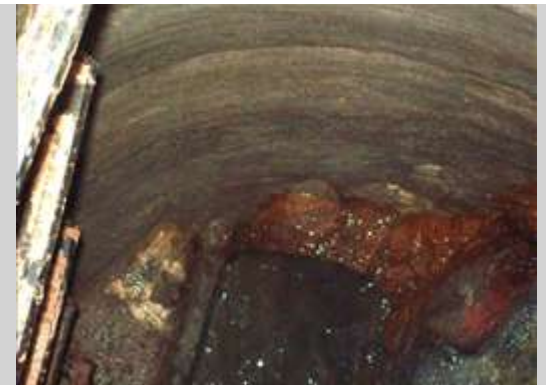
### 15 in. Circular Gravity Sewer Pipe In @ 6 O'Clock

Infiltration: **Evidence** Pipe Seal Cond: **Unknown**

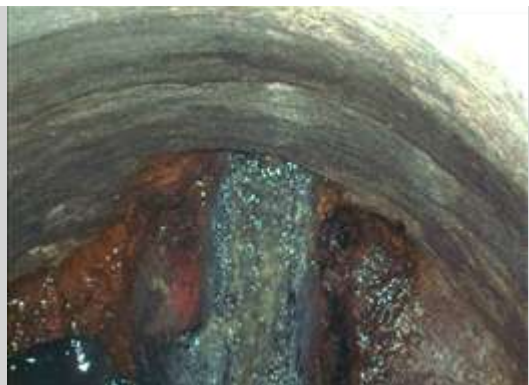
10 in. Circular Gravity Sewer

Deposits: ☐ None ☐ Mud ☐ Sludge ☐ Debris ☒ **Grease**

Deposits Extent: **Light**
